RedLINE® MOPPING INSTALLATION

**FOR USE WITH:
HOT ASPHALT, COAL TAR PITCH,
OR MODIFIED BITUMEN**

A MOPPING RedLINE® APPLICATION ON A PROTECTED MEMBRANE BUR ROOFING PROJECT

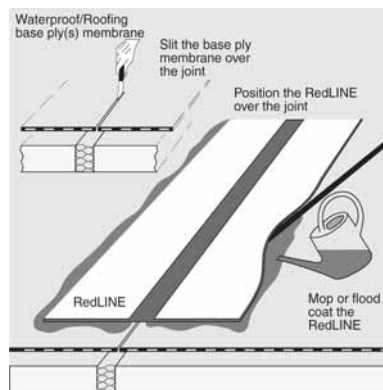
STEP 1: SUBSTRATE PREPARATION

Clean and dry the substrate ensuring it is free of debris and dirt. Install the base plies (in a BUR/Coal Tar Pitch*/Modified Bitumen). Slit the installed membrane along the building expansion joint, when the base plies span the joint gap, making sure that the cut is clean and continuous. Pack the expansion joint gap with compressible batt insulation.

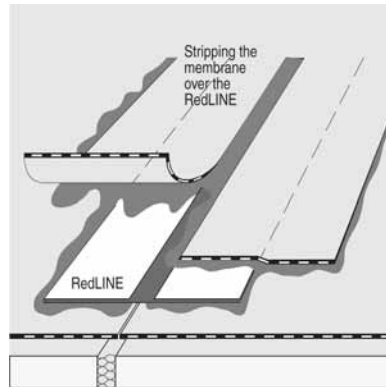
STEP 4: STRIPPING IN

Coat the top side polyester fleece with asphalt/bitumen or coal tar pitch. Install the top ply in the flood coat of asphalt/bitumen or coal tar pitch; the use of a mop is acceptable. Note that the asphalt/bitumen and coal tar pitch is at the correct EVT at the point of application. Fully coat the RedLINE fleece with asphalt/bitumen; an indication of this is a bleed visible along the ply's edge and no white fleece showing. Ensure proper fleece encapsulation, by "smoothing down" the RedLINE in asphalt/bitumen.

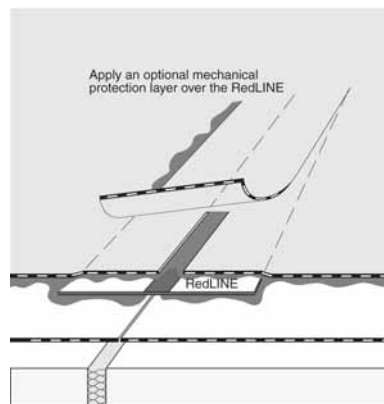
STEP 5: PROTECTION LAYER (OPTIONAL)

If an additional protection layer is required, mop or torch a compatible strip of modified bitumen membrane to one side of the joint, covering the exposed part of the RedLINE material. This allows for the free movement of the protection layer.

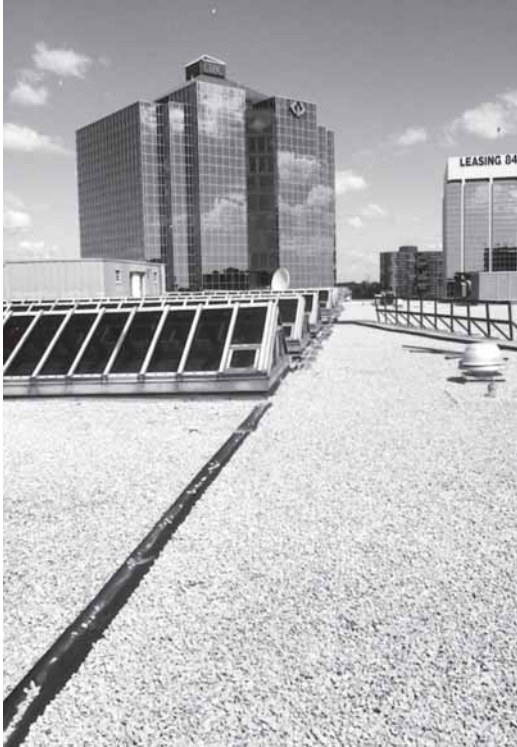
◀ Prior to the commencement of roofing the roof expansion cover is reviewed and examined. The photo on the left shows the covered expansion joint running across the roof. Note the skylights butting the expansion joint. The expansion cover was leaking and obstructed the flow of water across the roof to the drains on the right, resulting in water ponding between the skylights and compounding the leakage.

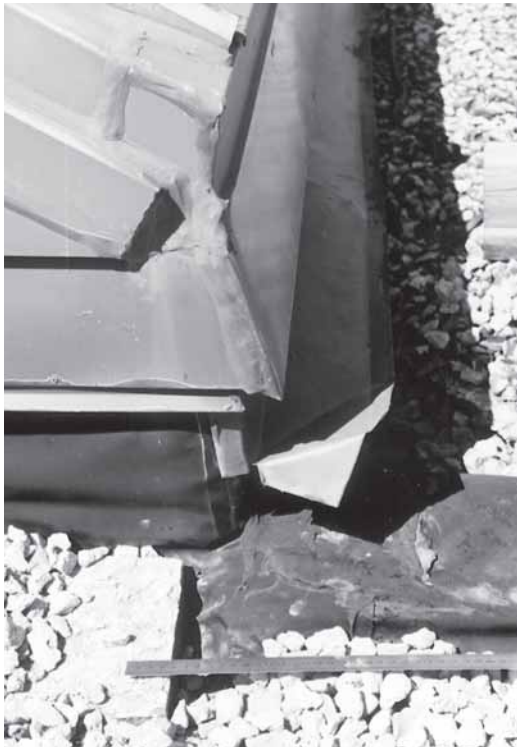
▲ Close up of the condition of the expansion cover at the corner of each of the sky lights on the roof.

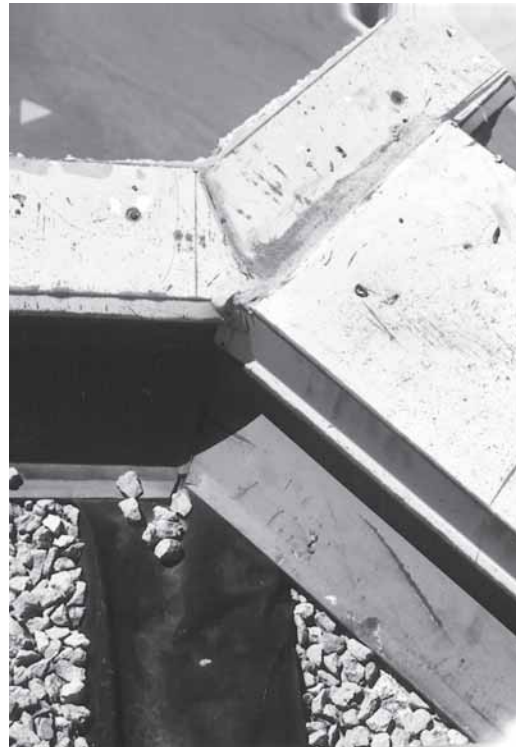
▲ Close up of the expansion cover termination at the edge of the building. Note the direction change on the roof parapet.

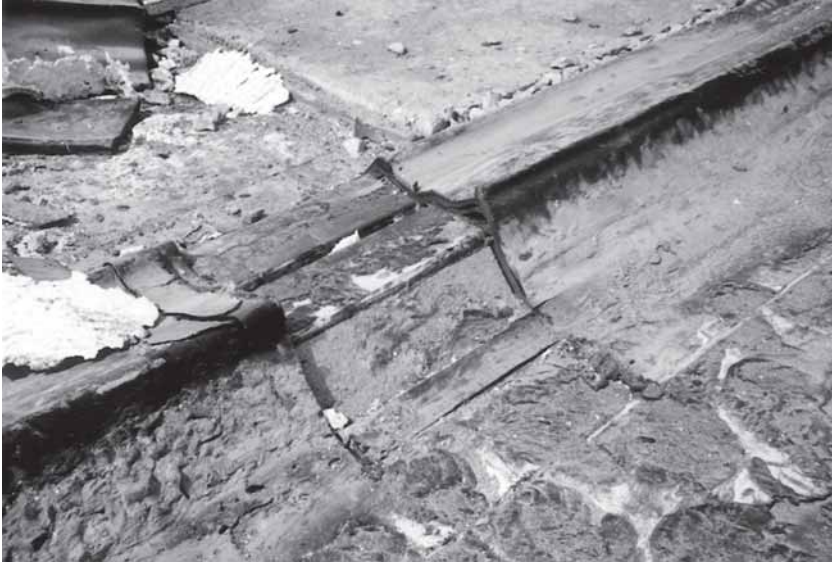
◀ The existing expansion joint, exposed. The joint was raised, hence obstructing the drainage of water. Over the years cutouts were made in the expansion joint in an attempt to alleviate the drainage problem.

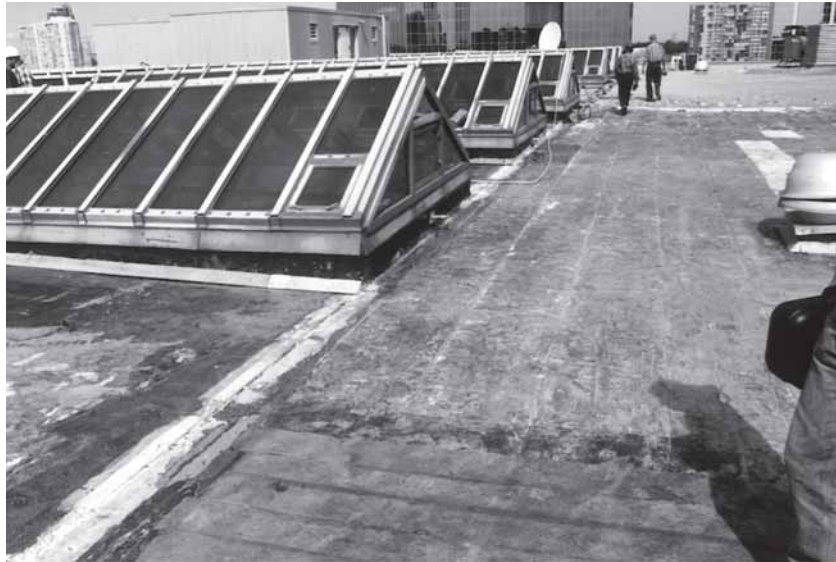
▶ Building expansion joint exposed, running along the skylight.

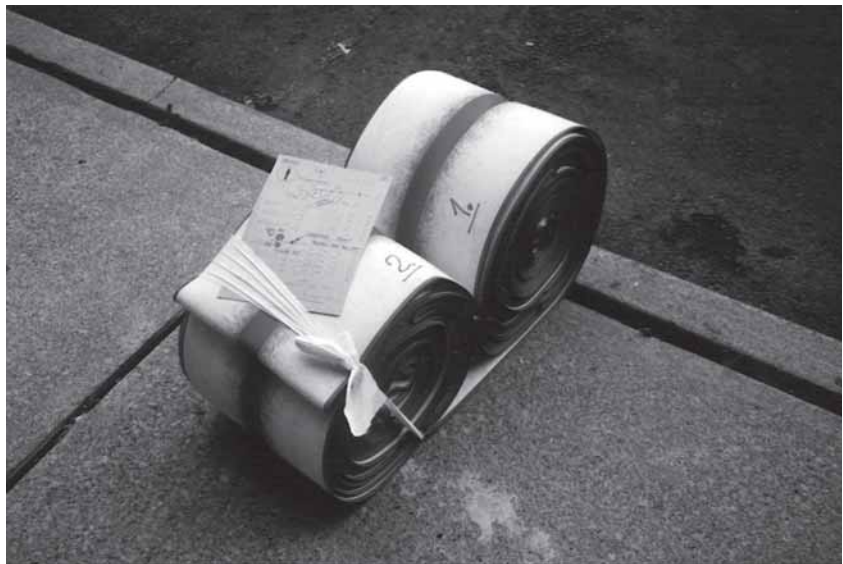
▶ The RedLINE waterproof expansion joint shipped to the site in a roll with site drawing, indicating starting point of installation and any other special features.

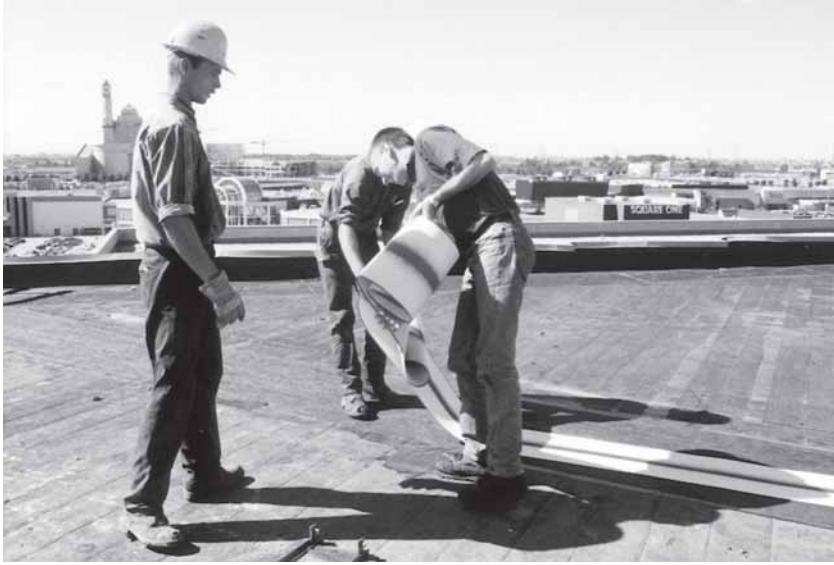
◀ The RedLINE expansion joint being unrolled on site to verify fit.

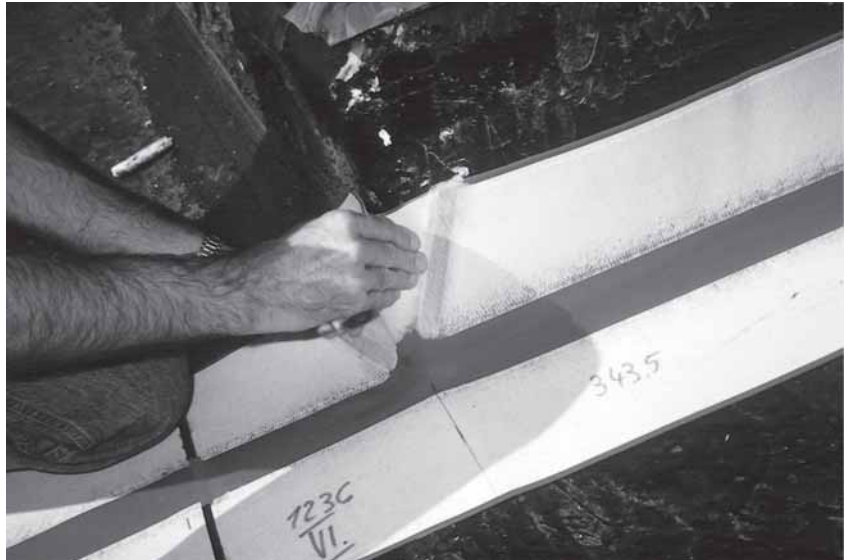
The RedLINE expansion joint custom corner detail at the roof skylight. ▶

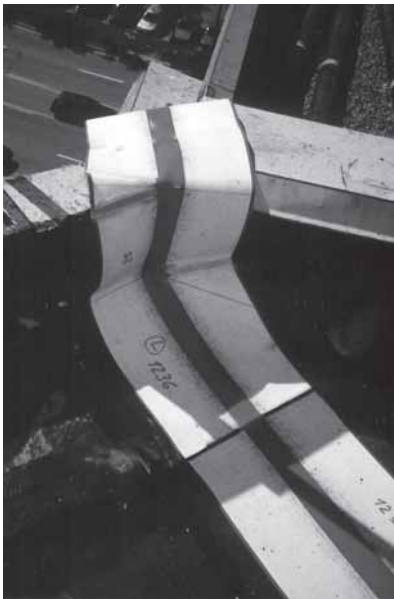
◀ The RedLINE expansion joint custom edge corner detail. The expansion joint changes both planes (from horizontal to vertical) and direction (twice).

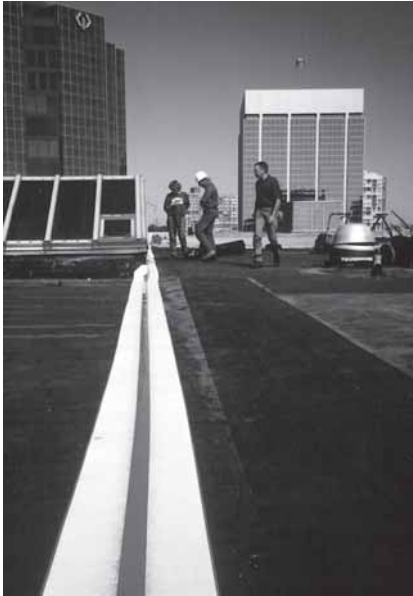
◀ Joint waterproofing is laid out along the roof expansion joint. Note the roofing base ply(s) have already been installed and cut along the building joint gap.

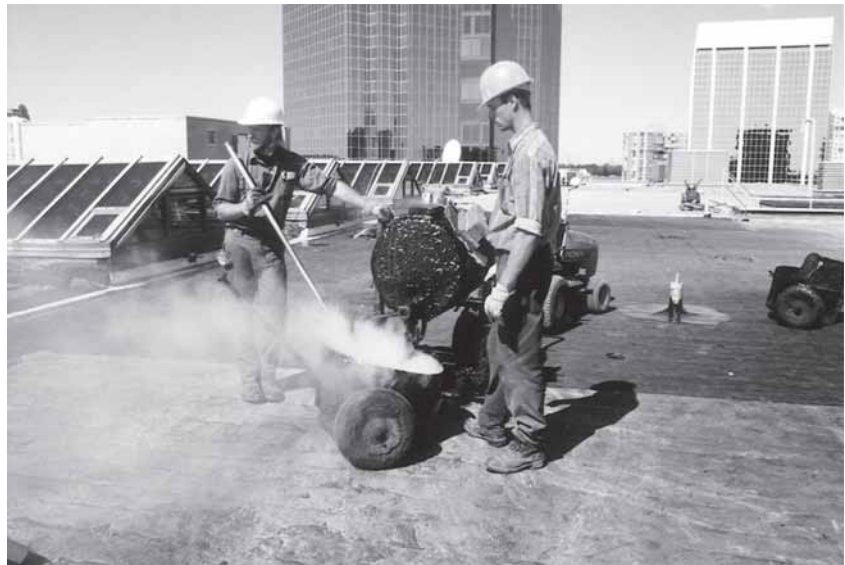
Asphalt in a bucket being readied. The asphalt was hot and at its recommended EVT. ▶

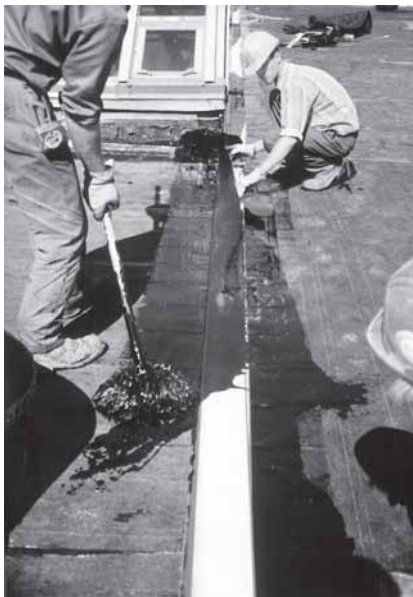
◀ Mopping the RedLINE expansion joint down. Note that both the base plies and the underside of the RedLINE are coated with asphalt.

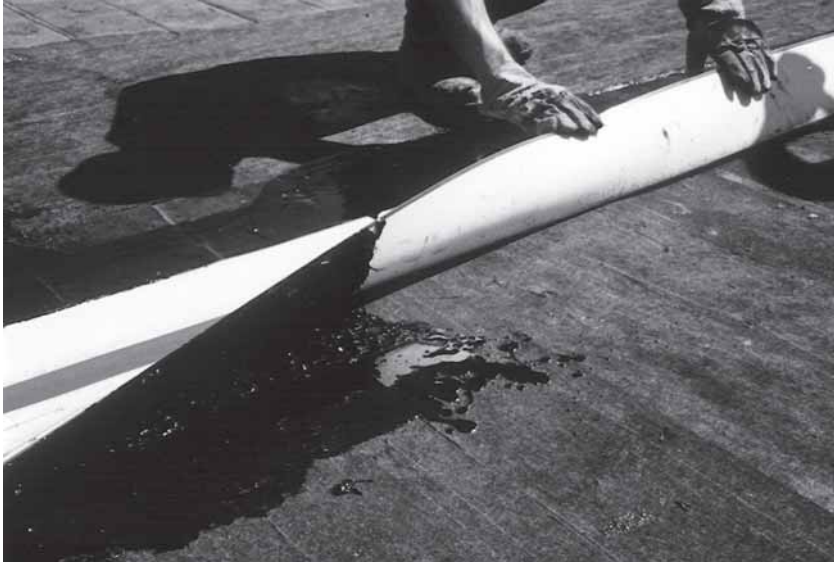
◀ A strong bond forms between the RedLINE fleece and the roof surface, totally encapsulating the fleece.

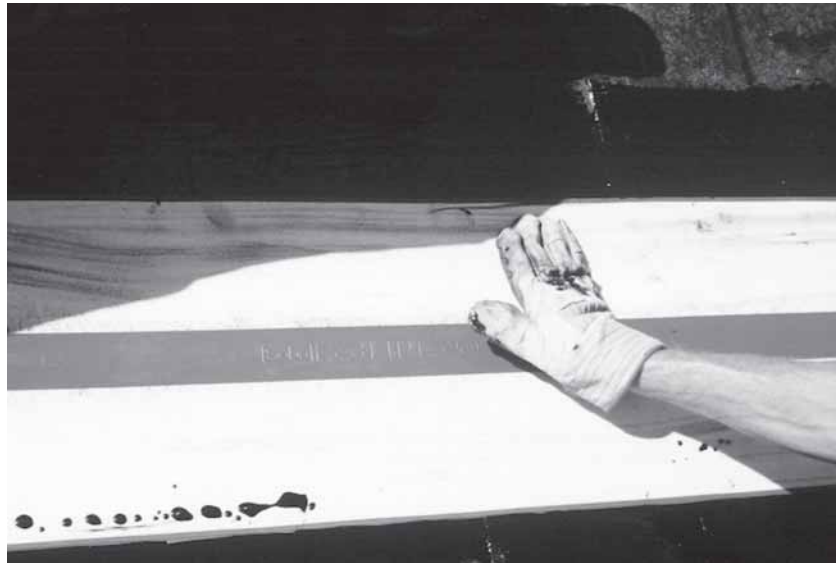
▶ The RedLINE expansion joint is smoothed down.

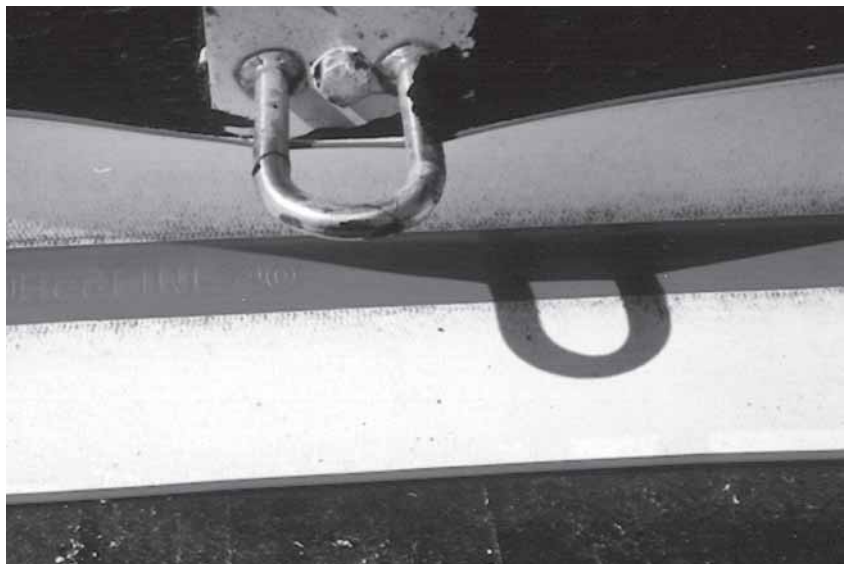
▶ The versatility of the RedLINE expansion joint allows the installer to easily work around details, such as this roof anchor.

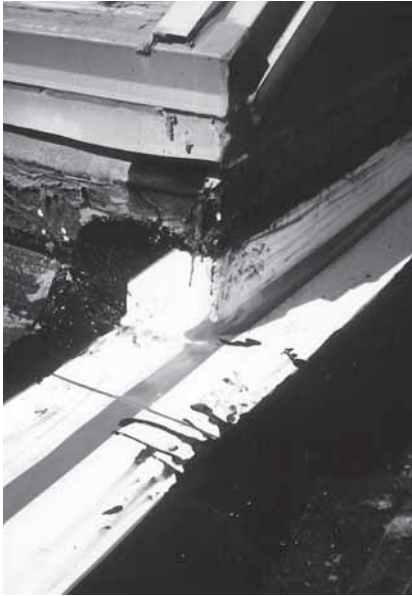
◀ The mopped down RedLINE at the skylight corner. The RedLINE material conforms to the shape of the skylight corner.

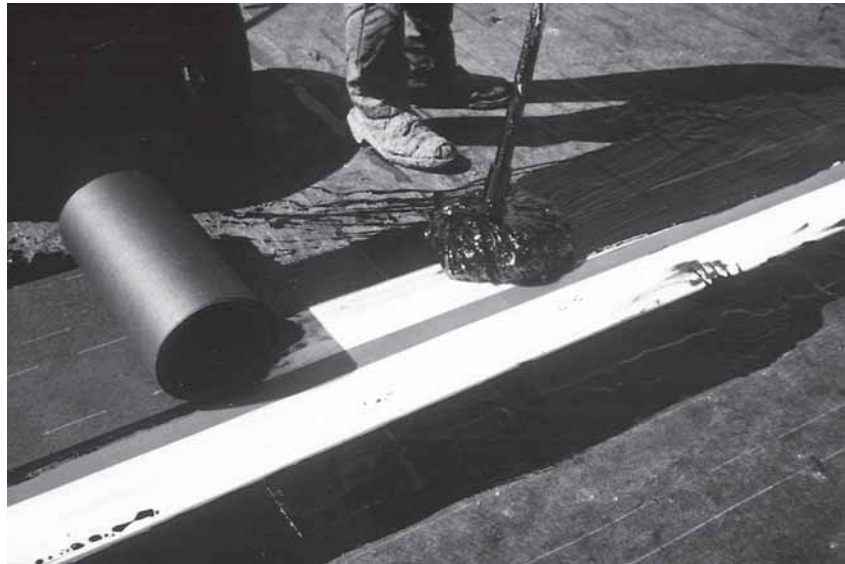
▶ Stripping in of the top surface of the RedLINE. Asphalt was applied by mop.

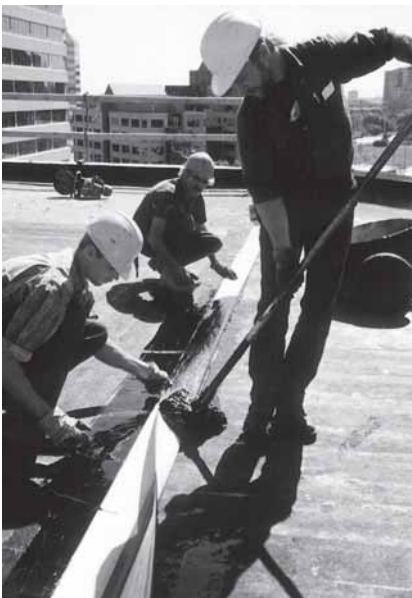
◀ RedLINE mopping in asphalt continues.

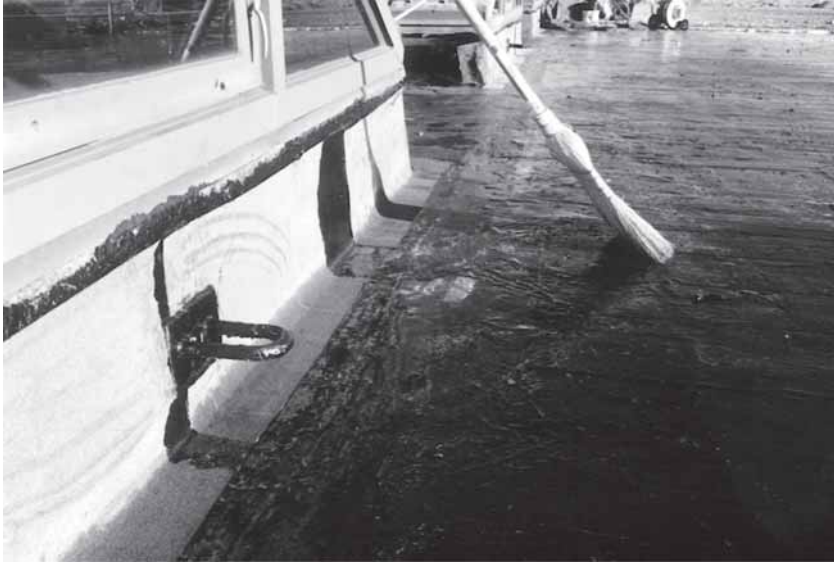
◀ The RedLINE expansion joint installed along the roof skylight. Note the cold applied modified bitumen flashing.

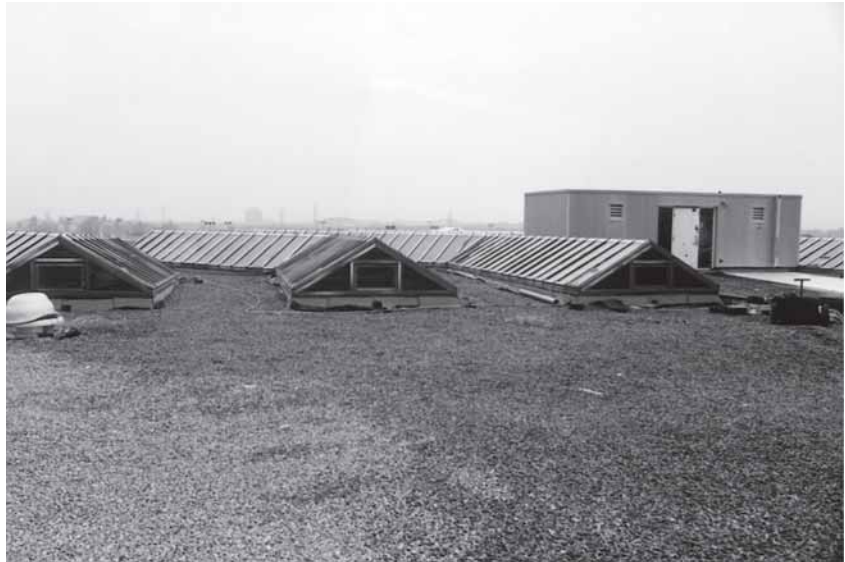
► The completed roof installation. Use of the RedLINE expansion joint achieved the two primary objectives initially set. A high performance expansion joint which addressed the difficult skylight curb condition and eliminated the ponding water problem. The roof now has positive drainage.
